FIGURE 7: POTENTIAL IDENTIFIED SAFETY ISSUES

DISTRICT OF  
SQUAMISH

BLACKTUSK WAY

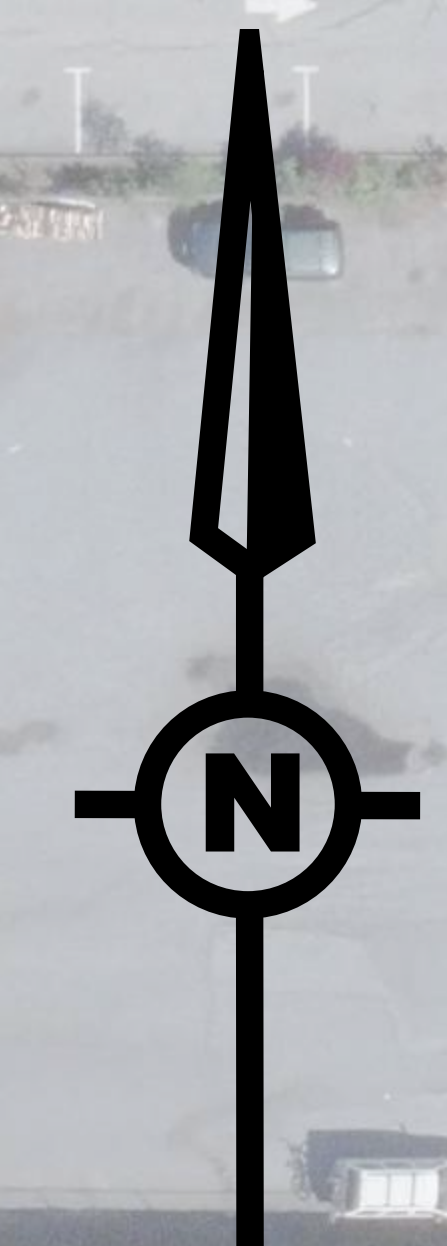
**T** No access from Hwy 99 to Tantalus Road heading south from Brackendale causes traffic congestion

**T** Vehicle speeding, particularly by Hwy 99 traffic

**A** High access density within a short distance

**A** Drivers going around the turning vehicles and use Garibaldi Way as a 4-lane road w/o left-turn bay

**P** Jaywalking reported between north and south sides of Garibaldi Way due to lack of crossing facility

**C** Discontinuity of the bike lane along Tantalus Road

**G** Drivers need to pull up further than the stop bar due to visibility issues

**A** Immediate left-turn to the gas station

**A** Proximity of the driveway to Tantalus Road southbound approach may cause confusion for left-turn vehicles

Long delay for left-turn vehicles **T**

Misaligned north and south legs at the intersection **G**

Southbound left-turn drivers from Tantalus Road not attentive of crossing pedestrians **P**

Driver's noncompliance to stop or pedestrians not using the push buttons **P**

Eastbound buses waiting at the near-side stop obstruct visibility to the special crosswalk **B**

Two eastbound bus stops within a short distance **B**

Condensed parking along Tantalus Road, and illegal parking due to overflow making visibility and access dangerous for pedestrians **P**

Backed up traffic at Hwy 99 intersection making turns onto Garibaldi Way difficult from accesses **T**

**G** Visibility issues when exiting onto Garibaldi Way

**A** Long delays/queues for vehicles exiting the Plaza parking lot

**A** Some drivers exiting the Plaza parking lot from south due to congested accesses onto Garibaldi Way

Impatient drivers going through Chevron gas station to avoid long delay/queue **A**

Lack of sidewalk along both sides of the Plaza access **P**
